Preliminary Report on an Investigation of the Ages of Cultural Sites at Mūʻolea, Maui*

Thomas S. Dye, Ph.D.

December 26, 2007

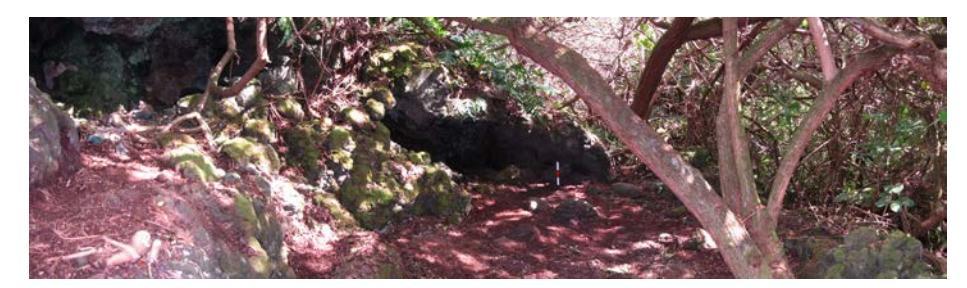
the tube at the east end. A terrace approximately 3 m wide with a wall of stacked cobbles about 90 cm high at its edge fronts the lava tube, creating a relatively level and spacious living surface (fig. 1). Due to the roof collapse, space within the lava tube is rather close and cramped, but it was undoubtedly used for shelter and a cultural deposit is found on its floor

Figure 1. Panorama of lava tube habitation, looking east. Note the boulders collapsed from the roof of the lava tube at the left, and the top of the wall fronting the terrace in the bottom right corner. The scale, located at test unit 1, is marked in decimeters.

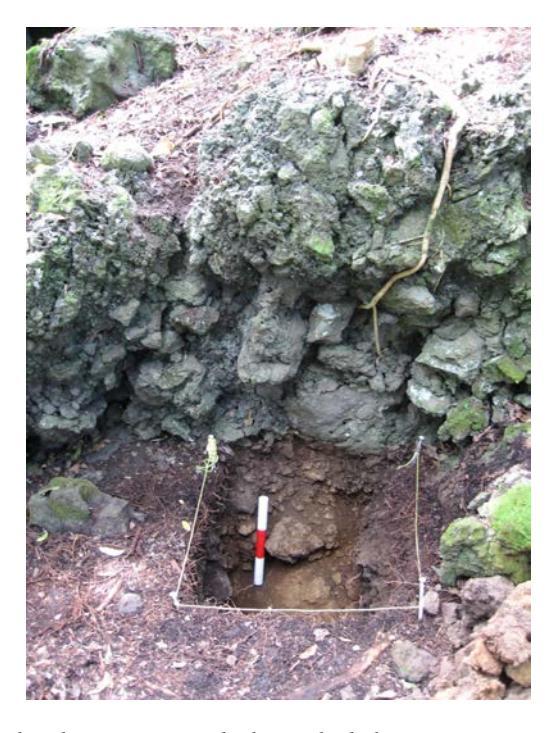
Two 0.25 m² test pits were excavated at the lava tube habitation. The first, test unit 1, was located at the east end of the entrance to the lava tube, at the back end of the terrace. The second, TU-2, was placed against the roof collapse near the middle of lava tube at the back end of the terrace (fig. 2).

Figure 2. Completed excavation at the lava tube habitation, test unit 2. Note the strong brown color of the rocky sediment under the collapsed boulders. The scale is marked in decimeters.

The excavation of test unit 2 failed to reveal a cultural deposit. These excavations indicate that the roof of the lava tube collapsed some time before the lava tube habitation was modified and used traditionally for habitation.

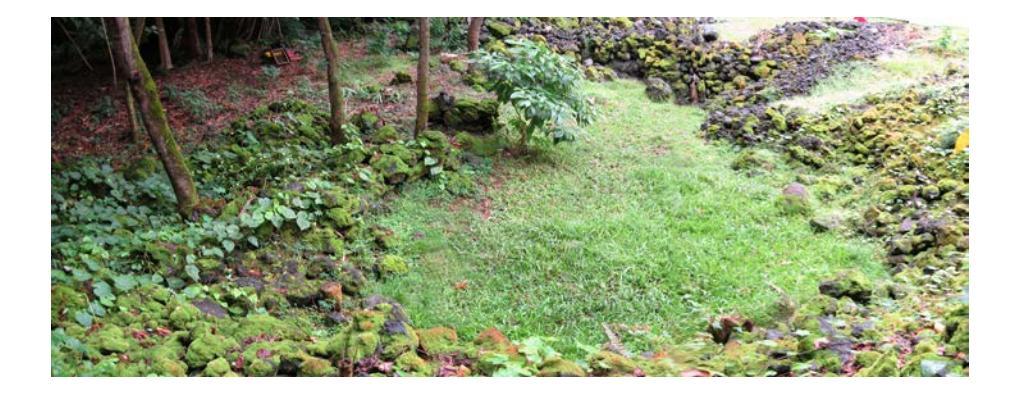
The mule pen site is a large enclosure, 12.5×6 m, set against a hill side (fig. 3). The high north, east and west walls of the mule pen site are facings that serve to hold back the hill. The low south wall, which is discontinuous, abuts the east wall, indicating that it was built at a later time. The east wall appears to be a facing for a roadway above it, that leads down to the flat area south of the mule pen.

Figure 3. Panorama of the mule pen site, looking generally west. The scale, at test unit 1, is marked in decimeters.

Test unit 1 was excavated against the west wall to expose the stratigraphic position of its base. Excavation revealed that the base of the wall is set just slightly below present ground surface on culturally-sterile soil. The excavation was terminated at 25 cm below

surface, when it became apparent that potential dating materials would not be discovered beneath the wall here. No materials were collected for dating the age of the wall.

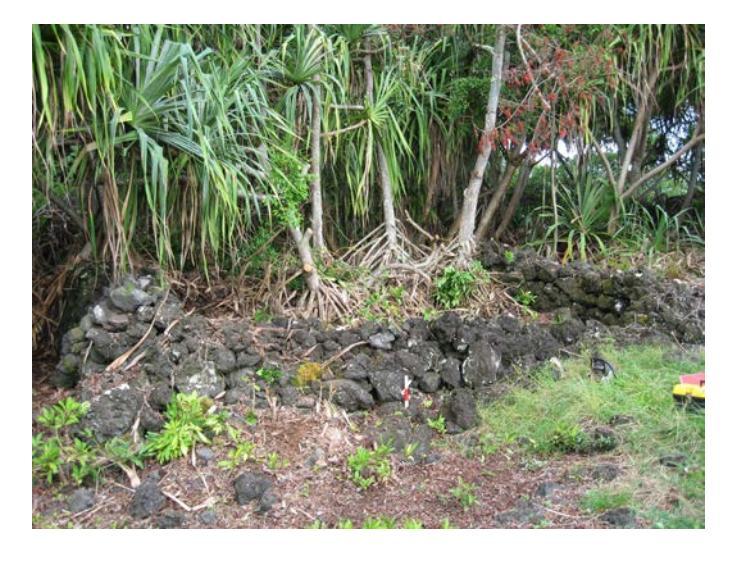
The coastal enclosure site is a rectangular enclosure near the coast built of loosely stacked 'a' \bar{a} cobbles and boulders. A single test unit was excavated against the inside face of the south wall at its western end to determine the stratigraphic position of the base of the wall. Excavation revealed a weakly-developed, rocky, black soil high in organic materials developed on an 'a' \bar{a} flow. The 'a' \bar{a} matrix has common voids, sufficiently large to allow the easy movement of materials down through the stratigraphic column. In this situation, it is not possible to be confident that material found beneath the wall is actually older than the wall; it is just as likely to be younger material that has worked its way through the voids under the wall. Consequently, no materials were collected for dating and the age of the wall wasn't determined.

Figure 4. The coastal enclosure site, looking east. The scale is marked in decimeters.

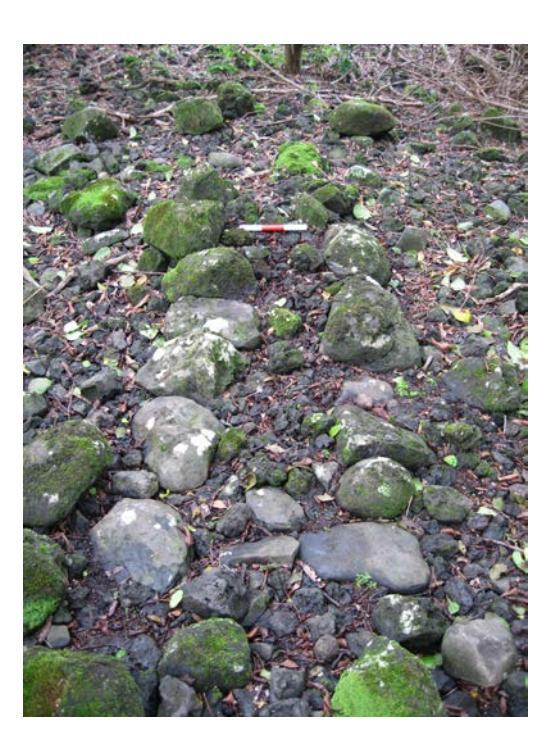
The coastal wall foundation site is a complex of features, now in generally poor condition, located in a low-lying area behind a rocky beach. The walls here are indicated by foundation stones, without a second or higher courses (fig. 5). Amorphous piles of stones were likely well-built platforms that are now deteriorated. In somewhat better condition are two low platforms that are likely graves.

Figure 5. Foundation stones of bi-faced, core-filled wall. Note the rocky surface outside of the wall. The scale is marked in decimeters.

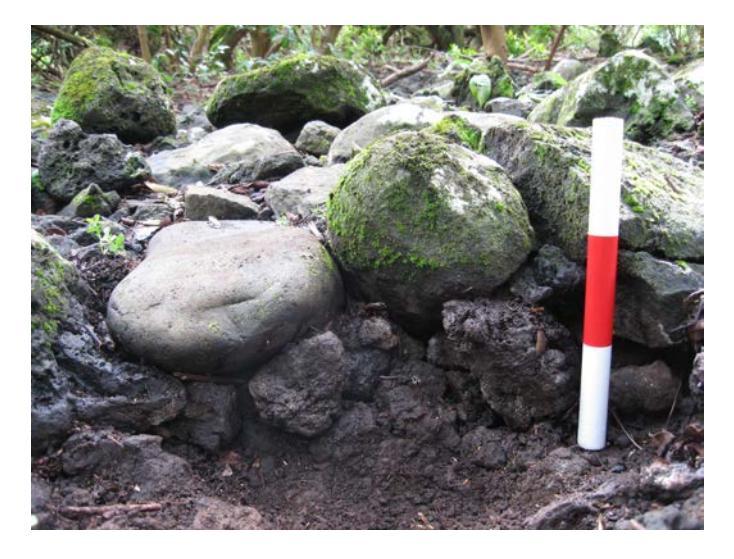
Excavation was carried out to find the base of a 90 cm wide wall foundation that runs in a *mauka=makai* direction for about 27.5 m. Test unit 1 was set against the west face of the wall. Excavation consisted primarily of removing cobbles and a small amount of sediment to reveal that the base of the wall was set on the modern, cobbly surface. The numerous voids between the cobbles provide ample opportunities for modern material

to work its way down the stratigraphic column, a situation that is not suited to dating the wall with the $^{14}\mathrm{C}$ dating method in this way. No potential dating material was collected.

Figure 6. Stratigraphy beneath the wall foundation, coastal wall foundation site. Note that the foundation stones of the wall were set on the modern, cobbly surface. The scale is marked in decimeters.

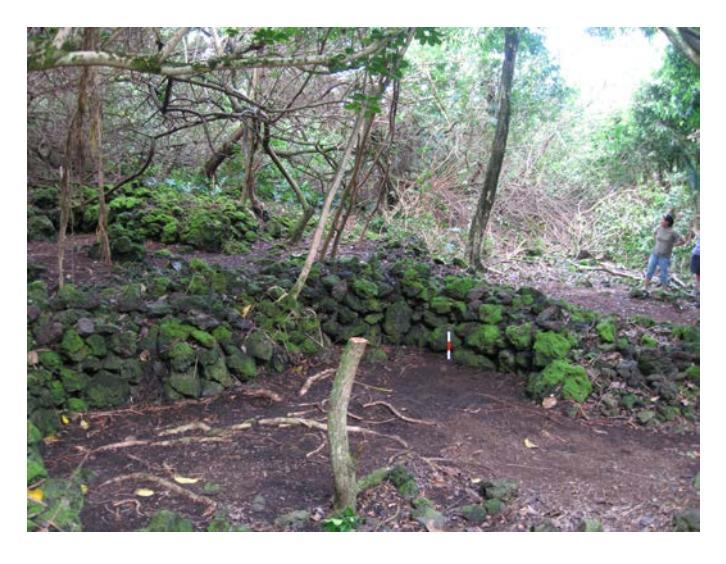
Two test excavations were undertaken at the coconut grove site. Test unit 1 was excavated inside the south wall of a partial enclosure (fig. 7) to a depth of 50 cm. The foundation stones of the wall are visible at the surface, and the base of the wall was discovered at 22 cm below surface. There is no cultural deposit, *per se*, but a small piece of clear glass was found at a depth of approximately 34 cm below surface, beneath the wall foundation. Although there is a slight possibility that this small glass fragment worked its way down the stratigraphic column, this seems unlikely given the compact soil here. The most likely explanation is that the wall was constructed in the historic period, at a time when glass was being imported to Hawai'i.

Figure 7. Location of test unit 1 at the coconut grove site, looking south. The scale, which is marked in decimeters, indicates the location of the test unit.

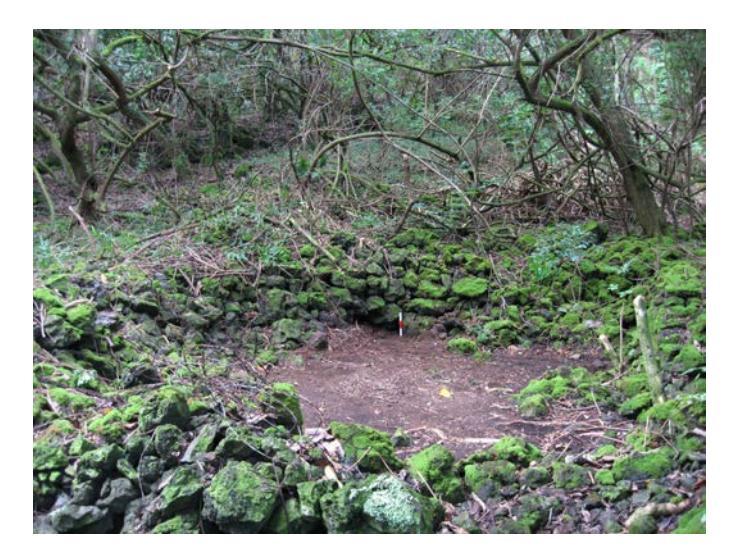
A second test unit was excavated against the north wall of an enclosure immediately *mauka* of the partial enclosure at which test unit 1 was excavated (fig. 8). This unit was excavated to the base of the wall, which was set in what appeared to be a natural soil. No cultural deposit was present and no potential dating materials were collected.

Figure 8. Location of test unit 2 at the coconut grove site, looking north. The scale, which is marked in decimeters, indicates the location of the test unit.
